Dallas Love Field Energy Assessment

City of Dallas

Dallas Love Field

06/2022

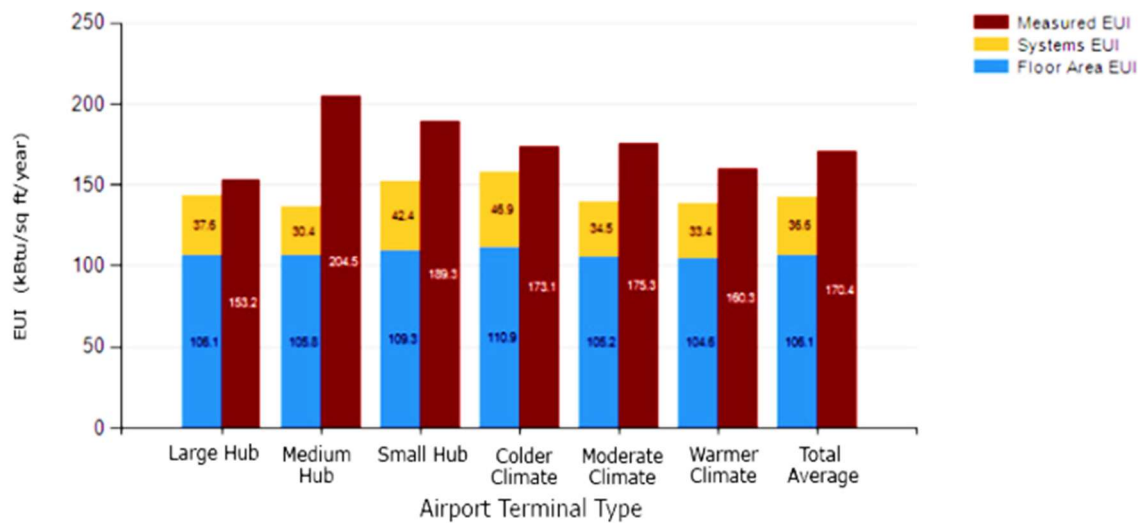
Figure 1 displays an output of ACRP 09-10, showing a breakout of EUI for systems (including central plant systems) and floor area, which incorporates lighting and other energy used in the actual space and a combined measured value.

Figure 1. ACRP 09-10 Representative EUI

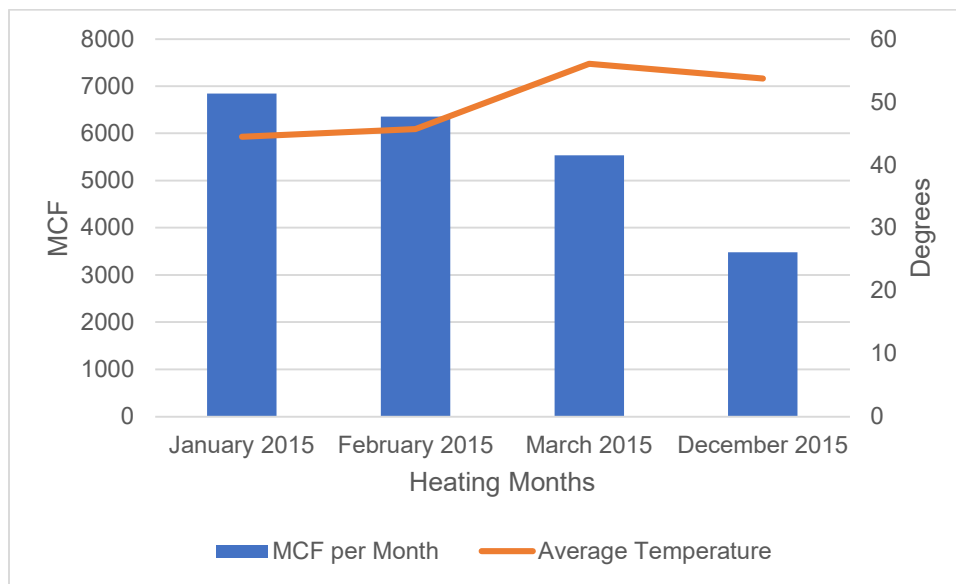
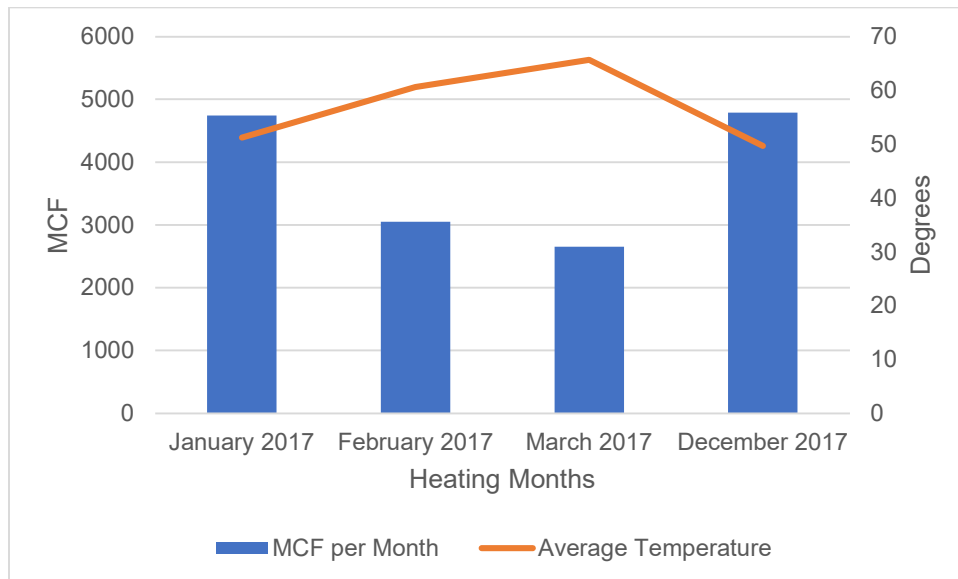
Examination of the natural gas data indicates significant consumption increase from 2016 through 2019. The natural gas utility consumption increased in 2016 to 2017 by 10,216 thousand cubic feet (MCF) or by approximately 25% and from 2017 to 2018 the natural gas consumption increased by another 1,860 MCF or an additional 5%. This data excludes the use of natural gas for cooking and food prep for the concessionaires. Natural gas consumption was compared to average temperatures during heating months to further analyze trends. **Figures 2 through 6** present the natural gas consumption during heating months compared to the average temperature.

Figure 2. Average Temperature vs Natural Gas Consumption 2015

Figure 3. Average Temperature vs Natural Gas Consumption 2016

Figure 4. Average Temperature vs Natural Gas Consumption 2017

Figure 5. Average Temperature vs Natural Gas Consumption 2018

Figure 6. Average Temperature vs Natural Gas Consumption 2019

From review of the natural gas utility data compared with the average monthly temperatures, conceptually, as the average temperature for the month increases, the amount of natural gas consumed should inversely decrease. Generally the trend supports the aforementioned expectation, but there is a significant proportional increase that is noticed between 2016 and 2019. Based upon the understanding of construction activities along with operation of the buildings, there were no significant events that should have increased the amount of usage significantly. In fact, the usage between 2015 and 2016 was reduced by almost 23%, which can be attributed to the new modernization project which improved overall system efficiency and operation, leading to reduced natural gas consumption.

Based on observations, the assessment team identified the heating hot water system as a potential issue. It is recommended that additional historical information from the Building Automation System (BAS) regarding the heating hot water system be evaluated to provide some additional support as to why the additional natural gas was consumed during these time periods.

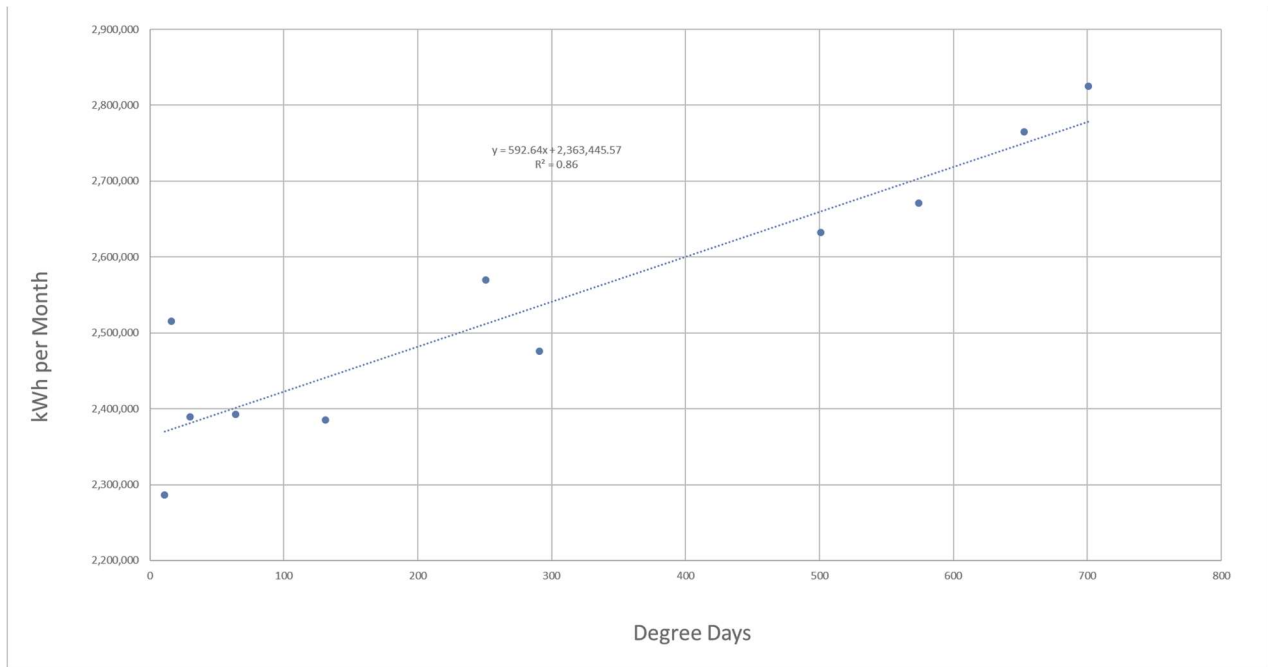
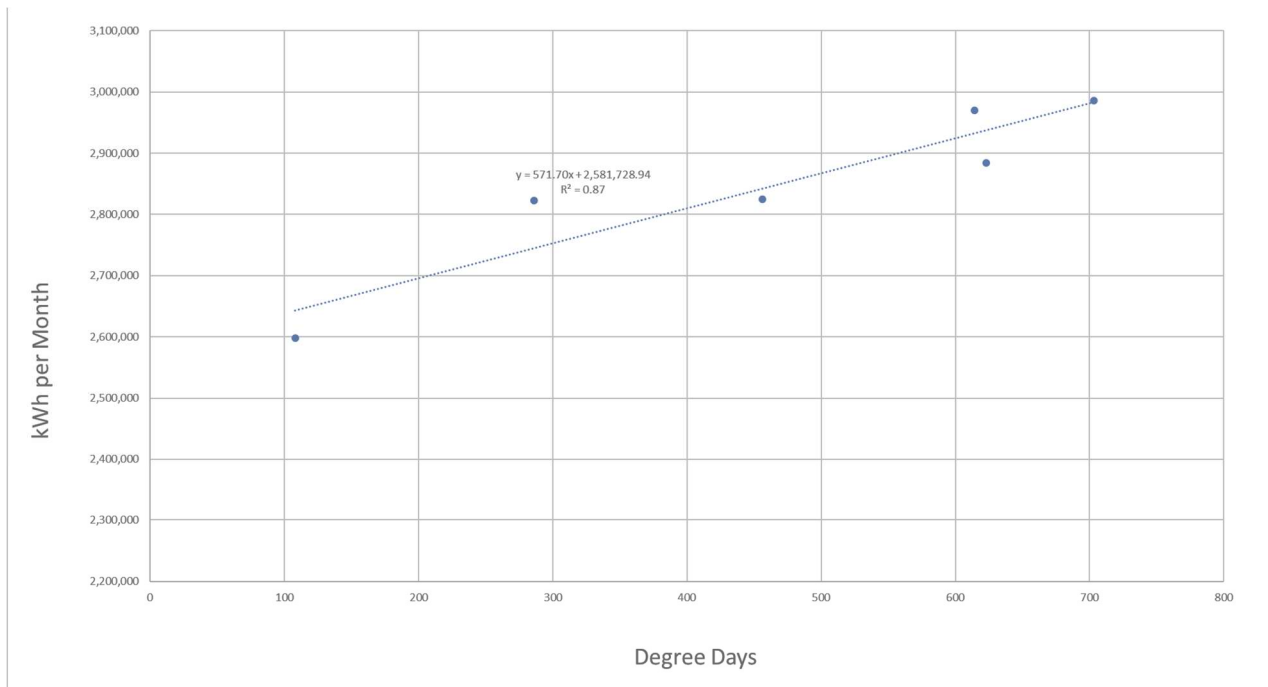
The following charts depict utility consumption performance from 2016 to 2019 per month with respect to the number of degree days. It is notable that the base loading of the Terminal and associated CUP increases by 8.4% CDD from 2,363,445 kilowatt hours (kWh) in 2016 to 2,581,728 kWh in 2019. This value indicates the minimum amount of energy consumed and excludes the impact of occupancy. This value is useful to assess, as examining it indicates that additional occupants or use is not the reason for additional consumption.

Figure 7. 2016 Electrical Consumption vs Cooling Degree Days

Figure 8. 2019 Electrical Consumption vs Cooling Degree Days

Based on information obtained during the assessment, that the thermal storage system was altered by removing the isolation valves, as well as temperature in the tank being adjusted, it is reasonable to assume that the change in operation resulted in an increase in energy consumption.

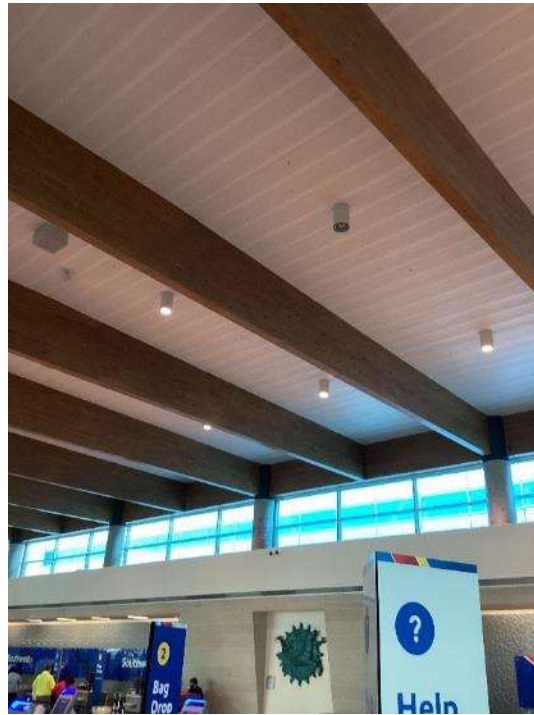
- Existing lighting appears to be mixture of T-3 and T-5 fixtures. Facilities in process of changing out fixtures to LED by means of lamp replacement. Large down lights in ticketing and baggage areas appear to be metal halide fixtures.
- Concourse lights are in the process of being changed out to more efficient fixtures.
- Reports from facility personal indicate that daylight harvesting controls and general lighting controls are not functioning properly.
- Lights in upper (ceiling) area of food court and concourse are running continuously all day and night and should be addressed.
- Lighting in Security/TSA area appear to all run continuously even when lanes are closed.

Image 1: Drop Lighting in Terminal Ticketing Area

- ECM: Downlights in terminal and concourse should be considered for replacement with LED fixtures for energy savings.
- ECM: Existing daylight harvesting system should be repaired and optimized to dim interior lighting in occupied passenger seating areas.

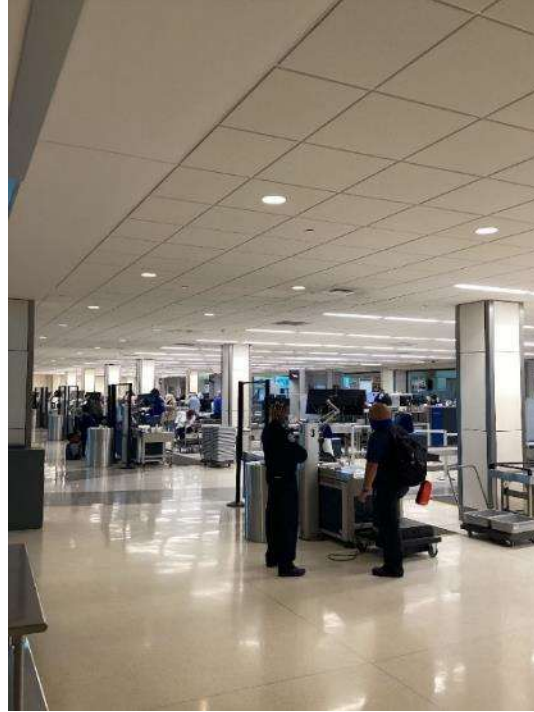
Image 3: Lighting in Security Checkpoint Area

- ECM: Utilize lighting control system to shut off lights in security during non-occupied/low occupancy hours.
- Further Study: Evaluate existing lighting system ability to shut down lighting serving inactive lanes during occupied hours

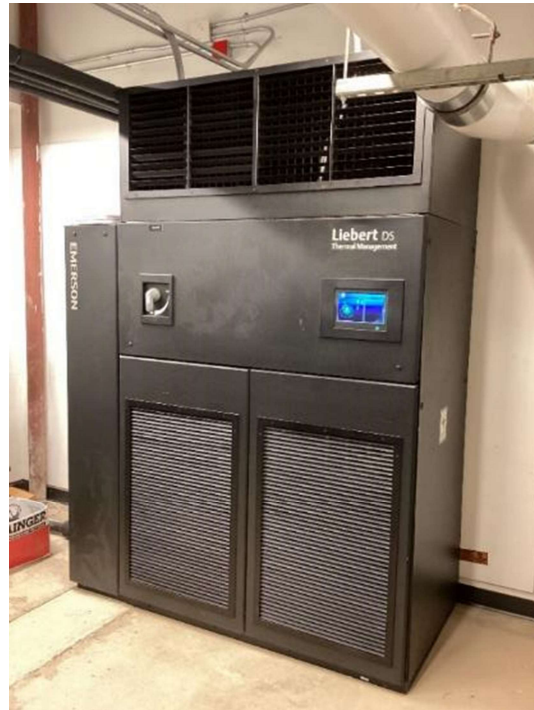
- Data/server rooms are served by Liebert floor-mounted computer room air conditioning (CRAC) units. Thermostats are currently set ~54-60°F.
- Concourse area is served by similar chilled water/hot water Temtrol air handling units located on the upper concourse mechanical level (Level 3).

Image 6: Typical Data/Computer Room Unit

- ECM: It is acceptable to run data centers/equipment rooms at elevated temperatures (it is common to maintain these spaces at 85°). Consider increasing room temperature to reduce energy consumption and increase equipment life.

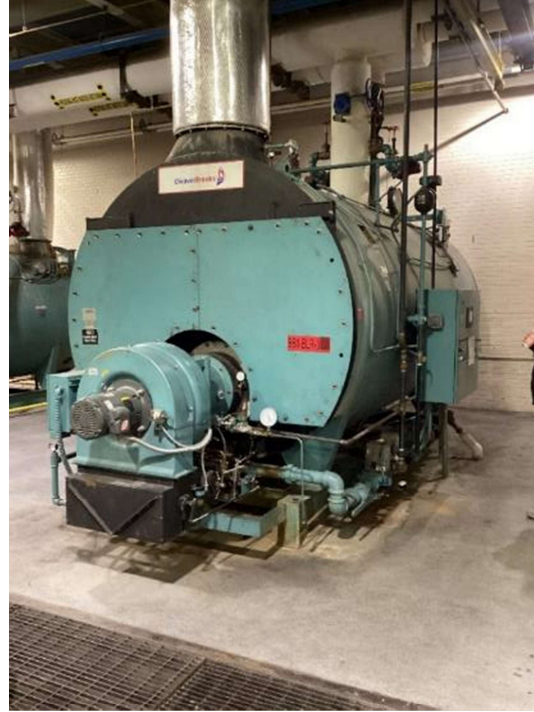
- Heating water is produced by (3) natural gas fire tube boilers. Two of the boilers were converted from fuel oil to natural gas.
- According to facilities, boilers are running at or above 85% efficiency.
- Each of the boilers has two pumps in a “primary/secondary” configuration per boiler.
- The “primary” (supply) pumps are equipped with variable frequency drives (VFDs) for speed control. The “secondary” (return) pumps are not equipped with VFDs.
- Controls logic were observed to energize new set of pumps for additional flow rather than staging on one pump or controlling VFD.
- Lead lag sequence would not de-energize if pump % fell below certain threshold

Image 7: Typical Hot Water Boiler

- ECM: Heating water pumping controls should be modified to minimize pump usage and increase efficiency. Controls may be modified to utilize VFDs, a single lead pump may be energized at a reduced speed rather than staging on two pumps at full flow, when only 30% flow is needed.

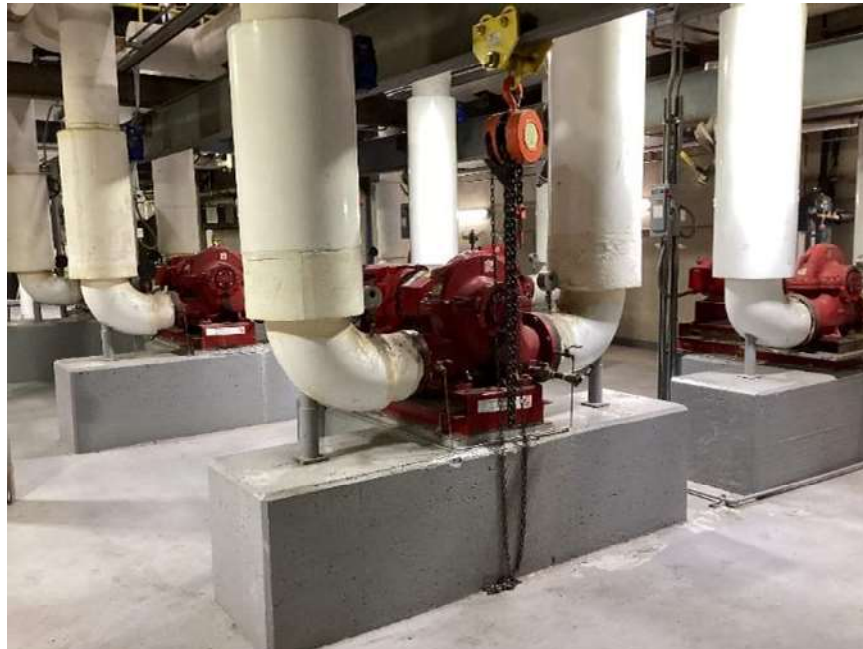
Image 8: Heating Water Pumps

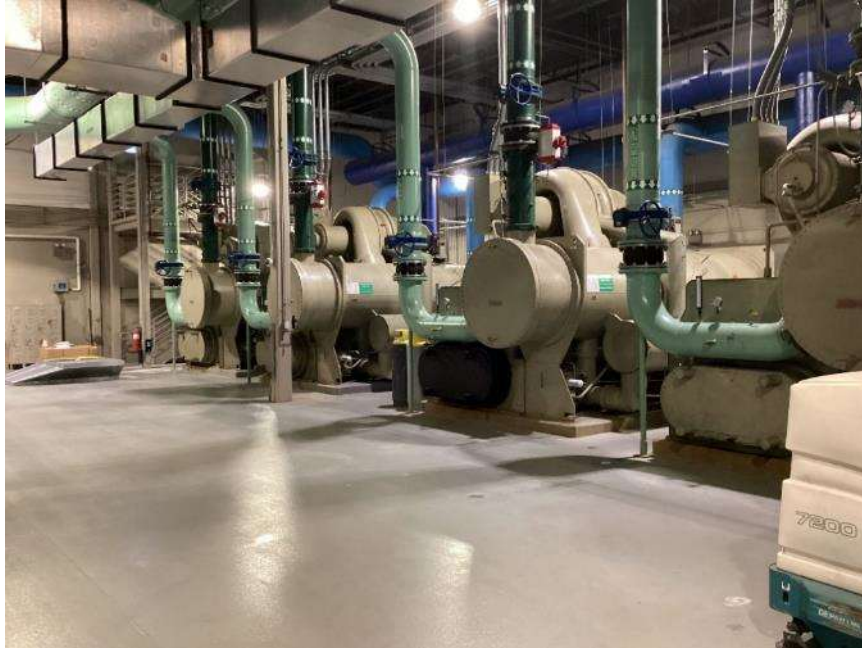
- Chilled water system is served by (4) 1,400 ton constant speed Trane centrifugal chillers. One chiller is currently down for maintenance. Facility team stated that all 4 chillers had to be operational in order to maintain temperature in peak conditions.
- Chilled water pumping system is designed in a primary-secondary configuration with (4) 40 horsepower (HP)/2,100 gallon per minute (gpm) primary chilled water pumps that pump the chiller loop and (3) 200 HP/3500 gpm secondary chilled water pumps with VFDs that distribute chilled water to the terminal and other buildings. Secondary pumps are controlled off differential pressure. Pumps are in good working condition.

- Facility personnel indicate that significant fouling is occurring in chiller tubes due to chemical water treatment installed in the last few years.
- Chiller's schedules (equipment rotation) are assigned manually and adjusted daily by facility staff according to weather forecasts.

Image 9: Chillers

- ECM: Recommend adding Variable Speed Drives (VFDs) to chillers to allow chillers to reduce energy consumption and minimize over pumping.
- ECM: Resolve issues with heat exchanger and enable free cooling whenever possible to save energy usage.

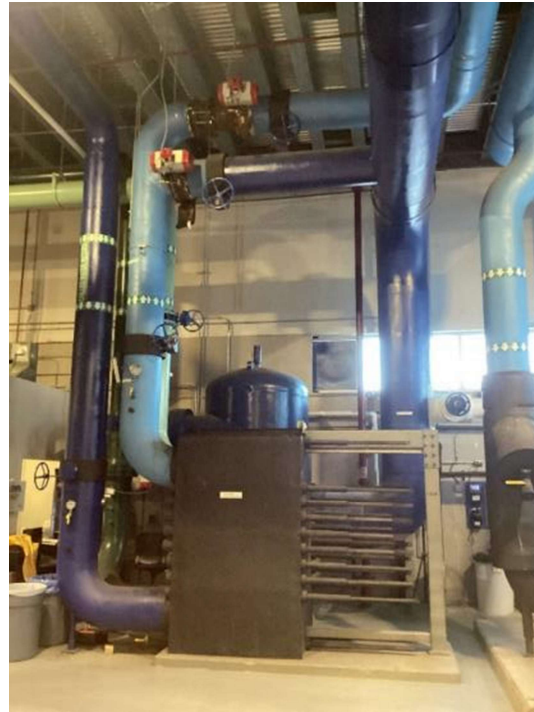
Image 12: Unused Heat Exchanger

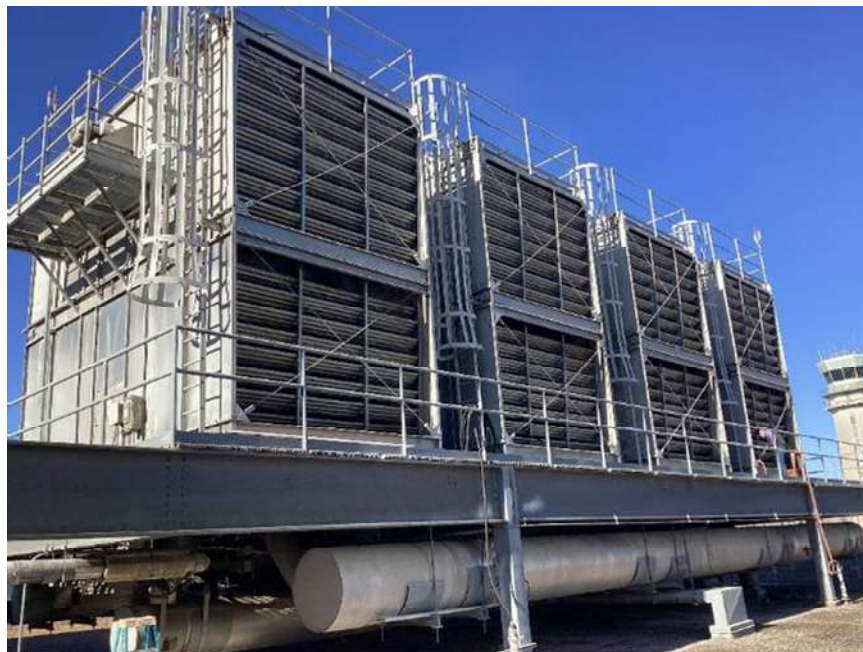
- Condenser water system is served by (4) 100 HP/4200 gpm condenser water pumps and (2) cell cooling towers for a total of (4) four cooling tower cells. Each cell is factory rated for 1,056 tons.
- Cooling tower basin sweeper system did not appear to be operating.
- Noticeable buildup of scale/deposit on fill and in nozzles in/on cooling towers.

Image 14: Cooling Towers

- Further study: Water treatment should be evaluated, significant buildup on cooling towers was also noted during observation. This issue should be addressed and resolved to increase chiller and cooling tower efficiency as well as useful life of each machine.

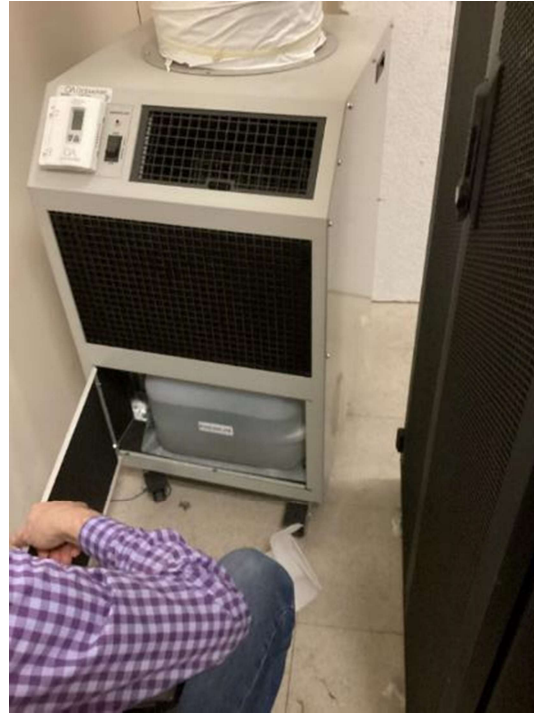
Image 16: Airfield Maintenance Building Data Room De-Humidifier (Full)

- ECM: Occupancy sensors or time-of-day timers could be added in the garage space to reduce usage when bays are not being used.
- ECM: Humidity issues in data room should be addressed. Humidifier should be emptied when full. Ductwork insulation and piping insulation in 116 Mechanical Room should be repaired where damaged for test port installation. Rusty fan cover on condensing unit should be replaced. Radiant heater thermostats should be relocated for more accurate occupied space reading.

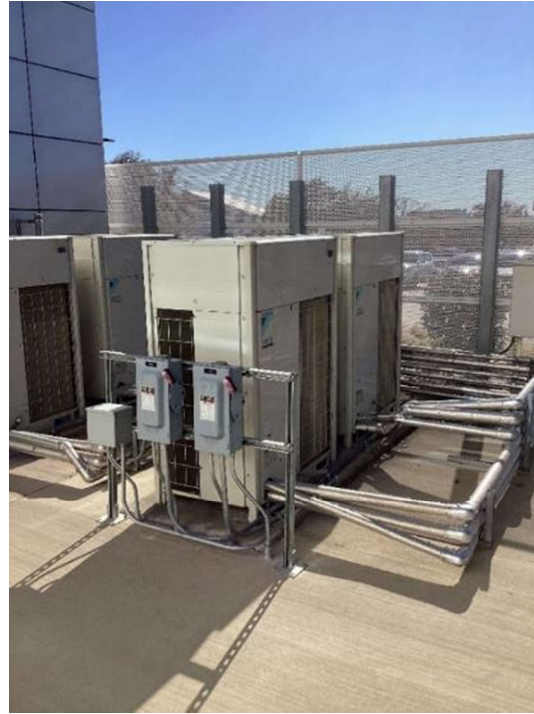
- Building is served by a Daikin VRV system with heat recovery. (3) REYQ168 14-ton units and (1) REYQ144 12-ton condensing unit are located in rear of building.

Image 18: Administration Building VRF Condensing Units

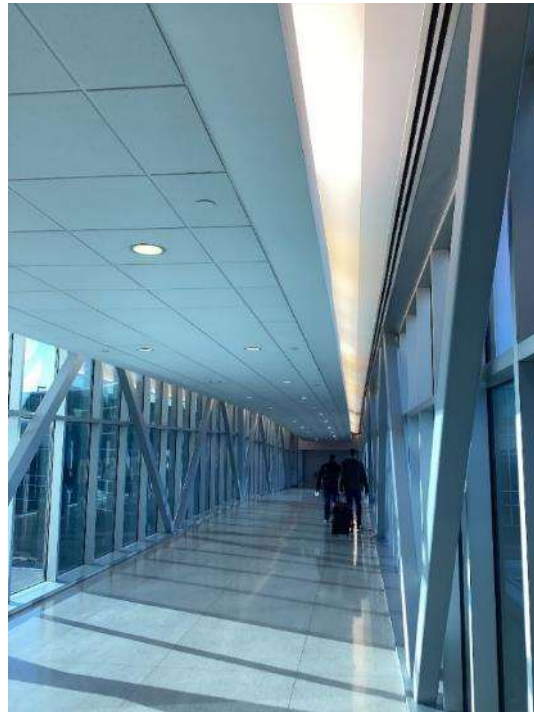
- Mood lighting and space lighting in sky walk appear to be running continuously.

Image 21: Skywalk Lighting
